TMDXEVM6472
Engineering Change Order (ECO)
About RGMII-ID setting of ETH PHY
For PCA REV: 18-00065-01 & 18-00065-02 ONLY
11-JANUARY-2010

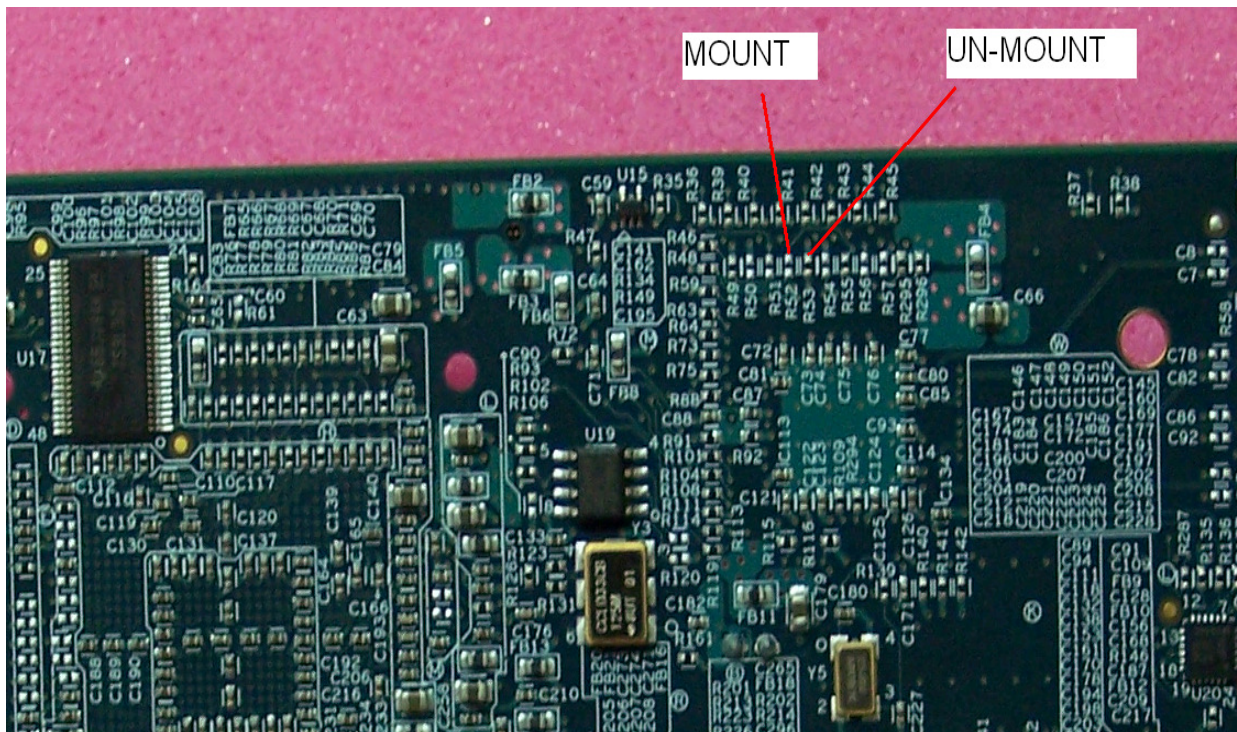
Above versions of board design contains Marvell #88E1121 ethernet PHY (U2). The default board configuration for 88E1121 sets RGMII-Internal Delay timing using CONFIG[3] pin of 88E1121 as “11” meaning both RGMII TX and RX clocks are internally delayed by 88E1121.

This setting may work well for 10/100 Mbps data-rate but it could have an un-reliable RGMII timing when PHY is operated for the data rate of 1000 Mbps. The impact could be an increase in failure rate of ethernet packet delivery at 1000 Mbps data-rate. This could also impact the EMAC boot of C6472 as during network boot-up RGMII EMAC of C6472 operates at 1000 Mbps data-rate.

Figure: Position of R52 and R53 – at bottom side of PCB

The better RGMII-ID setting at CONFIG[3] pin of 88E1121 should be “01” meaning RGMII TX clock is NOT internally delayed and RGMII RX clock is internally delayed.

Above change can be done by simply changing the assembly of 0E resistors R52 and R53. Resistor R52 should be **mounted(0E)** and resistor R53 should be **un-mounted**.
