C6657 Lite EVM Known Issues

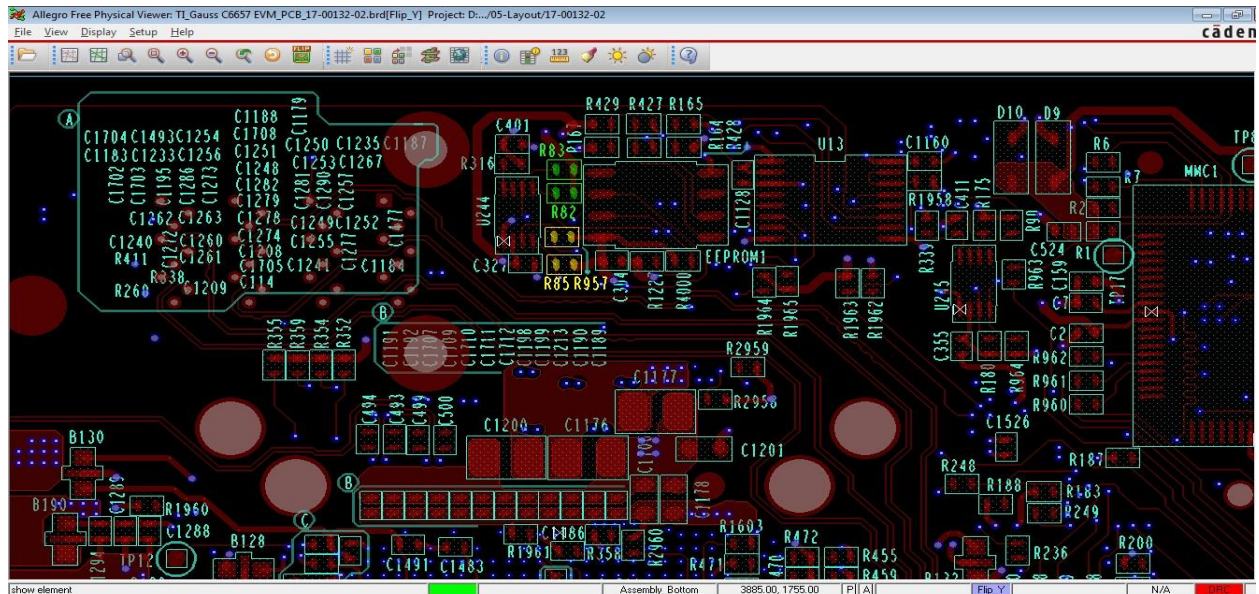
Figure 1: Bottom Pads and Bottom Assembly Layer

In **all versions** of EVMs, there are chances that the DSP could not read/write Ethernet PHY registers at few random occasions. This problem is more pre-dominant when MDC operated at 1 MHz or higher rate.

Workaround: Please Un-mount resistors R85 and R957 (highlighted below in yellow color). Change resistors R82 and R83 to 10K (highlighted below in green color).
