EVMK2E Known Issues

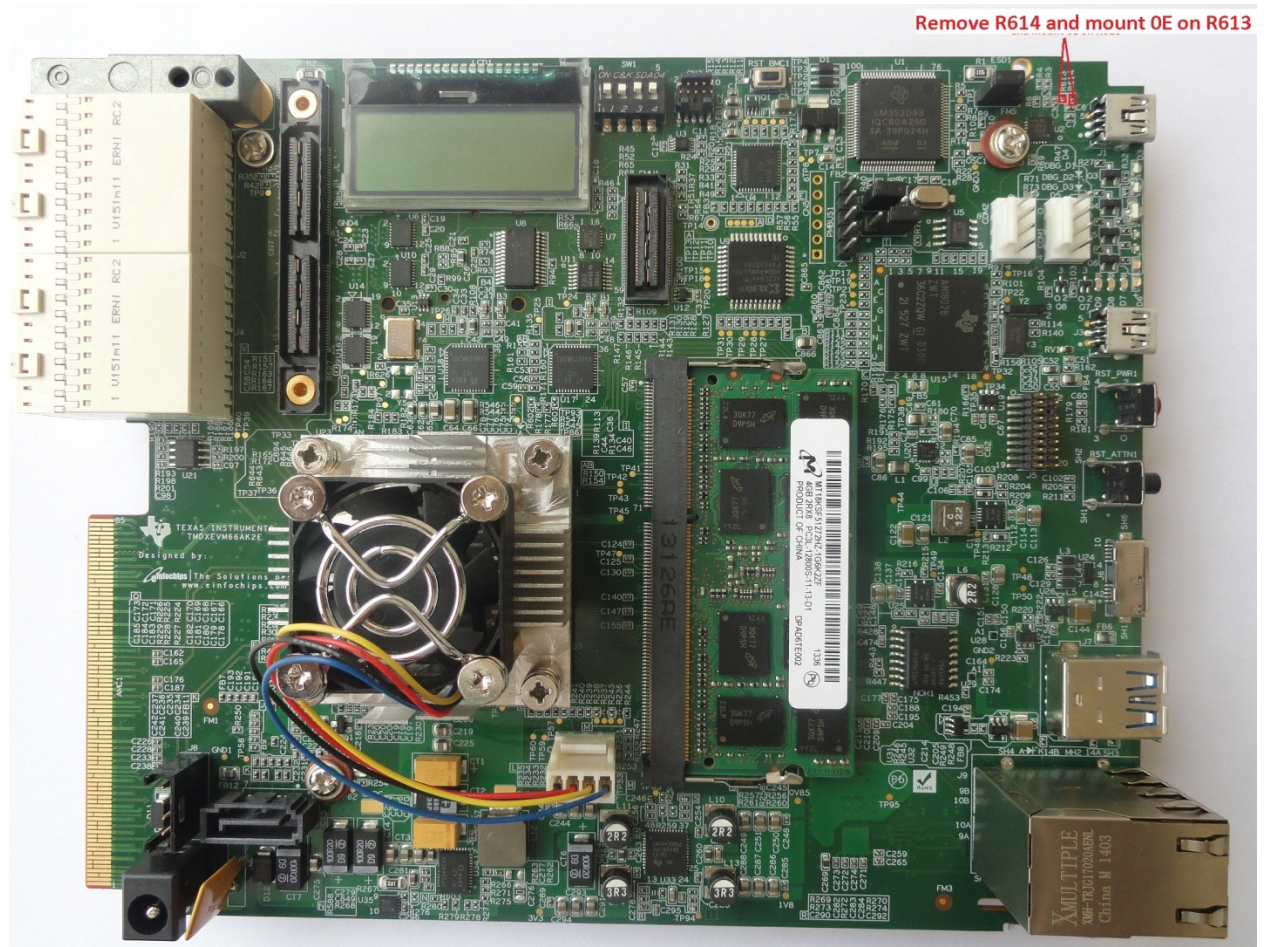
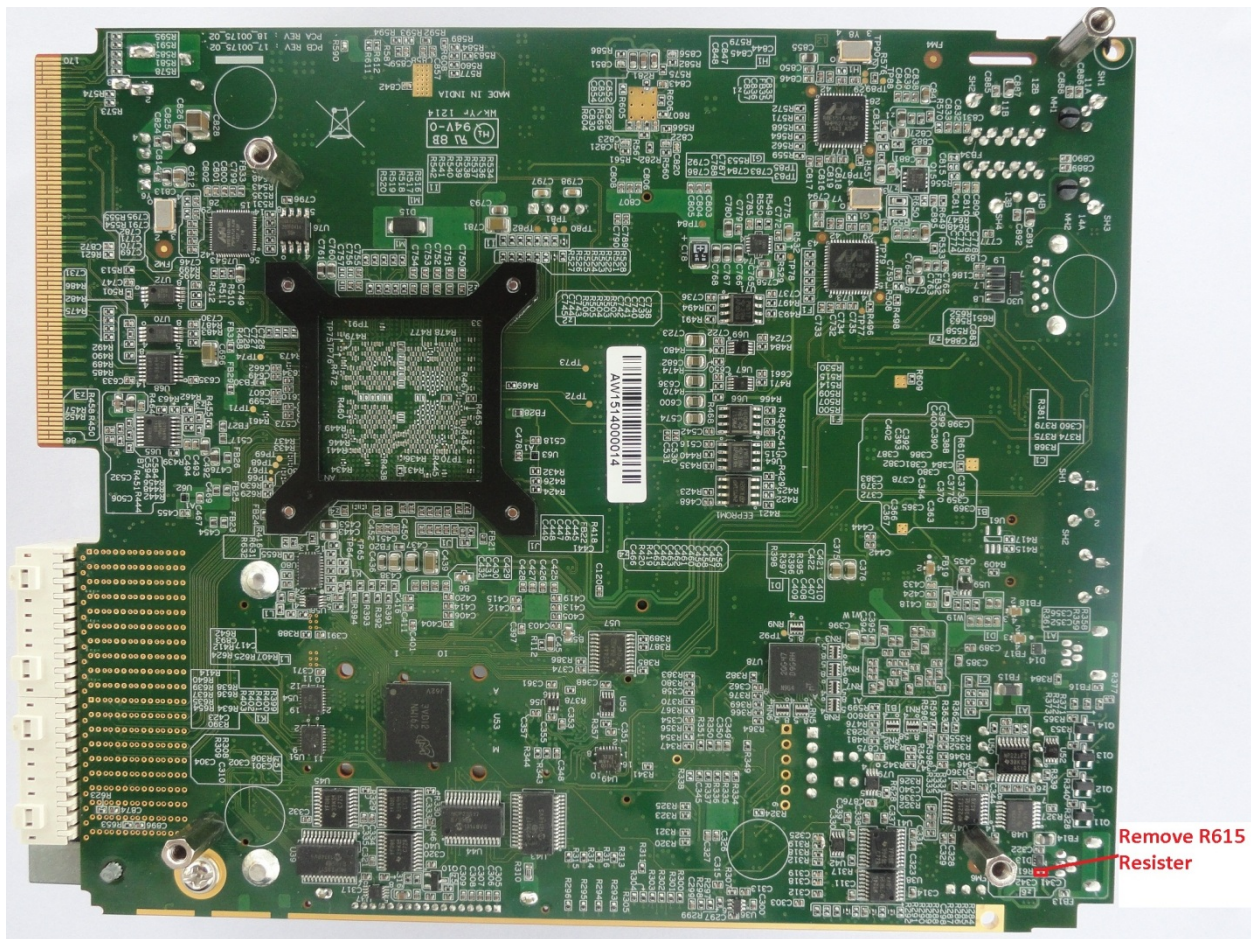
2. CP2105 (USB to Dual UART Convertor) Serial COM ports does not work when inserted into AMC chasses

In Alpha boards (EVM v 1.0.2.0) version of K2E EVMs, CP2105 (USB to UART converter) was operated on "VCC3V3_AUX" supply, So you can not access serial port from USB with management power. To access serial port using USB there are few hardware modifications required. Please refer below images for hardware modifications.

Remove R615
Resistor

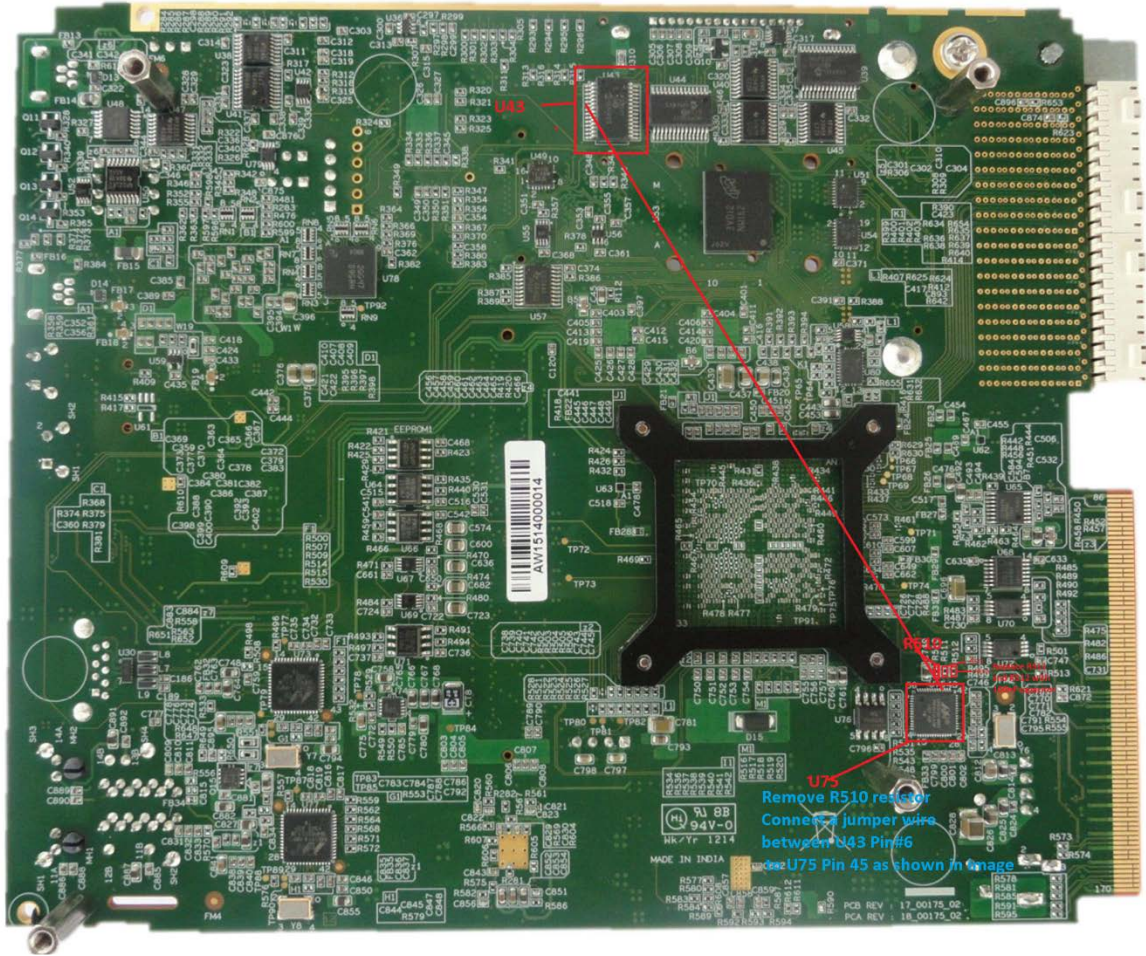
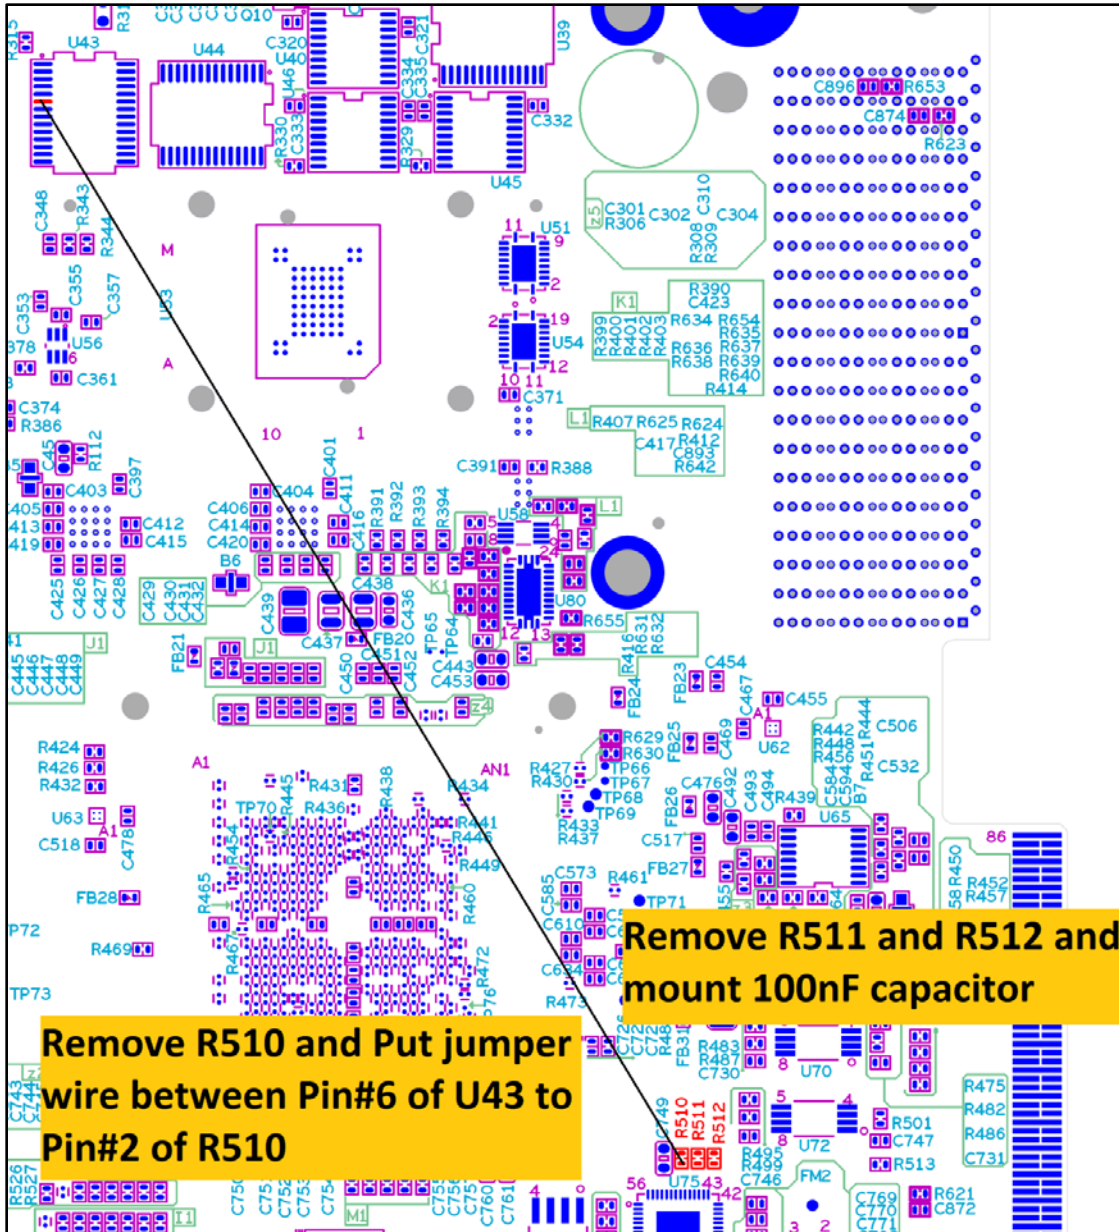
3. SATA detection Issue

In Alpha & Beta (EVM v 1.0.2.0 and 1.0.2.1) version of EVMs are not supported to SATA devices. Please remove R510 and put a jumper wire between Pin#6 of U43 to Pin#2 of R510 as shown in below Image. Please replace R511 and R512 with 100 nF capacitors as shown in below Image.

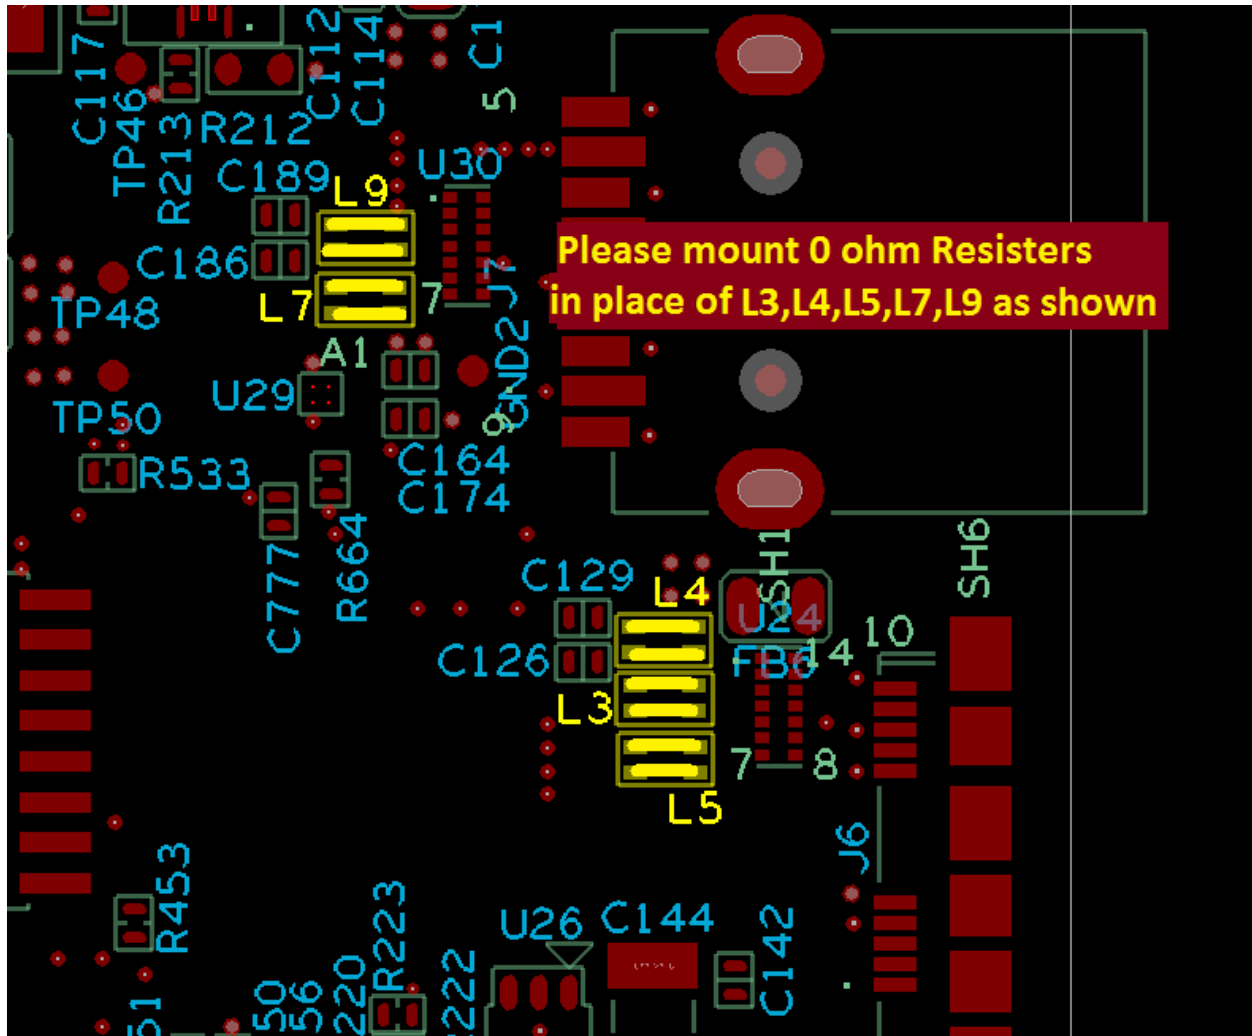
We have observed USB 3.0 link errors on K2E EVM board using USB protocol analyzer tool. EVM v 1.0.2.0, EVM v 1.0.2.1, EVM v 1.0.2.2 and EVM v 1.0.3.0 versions of EVMs are affected by USB link Issue. Both USB 3.0 ports of EVMs are affected by link error issue. These links errors point to some USB signal integrity issues on K2E and are causing issues in the driver functionality. Please find related hardware changes as below.

Please mount zero ohm resistors (0402 size) in place of L3,L4,L5,L7,L9 at (top side of board) as shown in below images.

L7,L9 Replaced with zero ohm resistors(0402 Size).
