# TCIEVMK2LX Known Issues

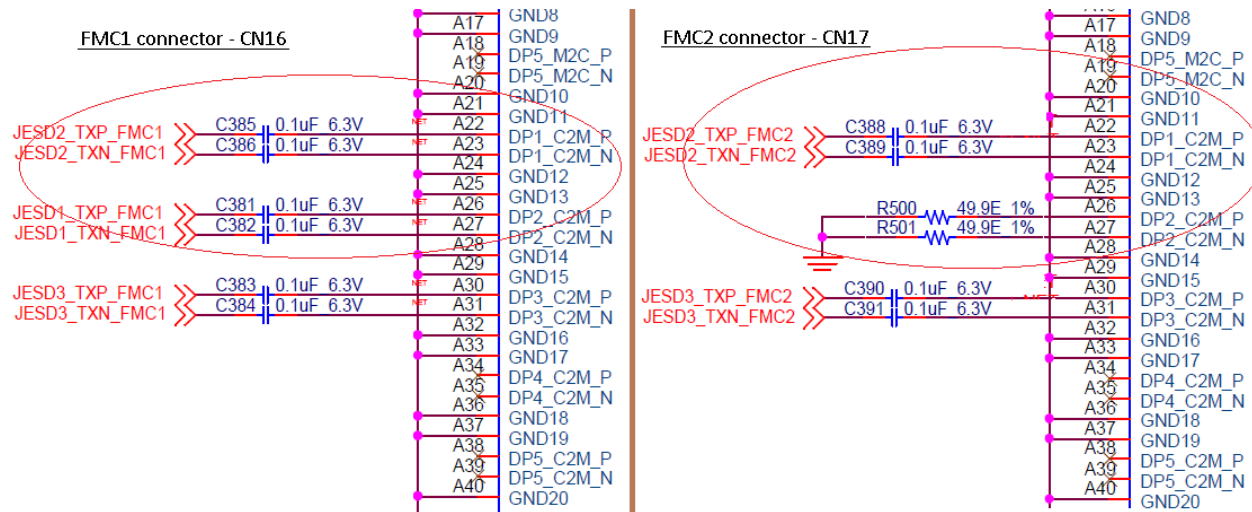
## 1. JESD TX lanes 1 and 2 swapping issue

In Alpha (V01) and Beta (V02) version of K2L EVMs, JESD TX1 and TX2 routing is as shown below picture. This is different from FMC standard pin mapping.

This issue shall be resolved from EVM v1.0.3.0 and onwards.

To resolve this JESD swizzle issue on board (V01 and V02), use TI's latest RFSDK.

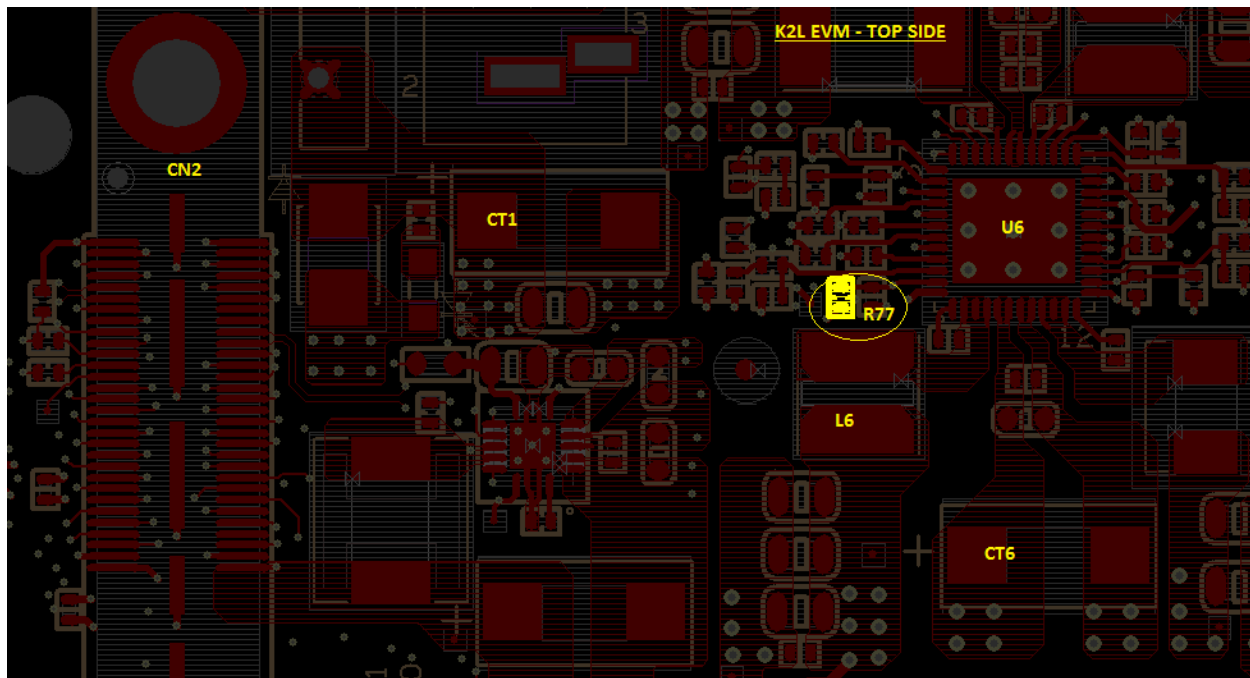
### 5. CVDD1 nominal voltage implementation as per the latest K2L datasheet revised Oct-2014

To resolve this issue on V01, V02 and V03 boards, remove 10.2Kohm resistor from R77 location and mount 7.68Kohm resistor. Refer below picture to identify the location of R77.
