# TMDSEVM6474L Known Issues

1. [Potential SERDES Clocking issue in TMS320C6474](#)
2. [Version number displayed on UART console during POST execution](#)
3. [Intermittent DDR2 data corruption](#)

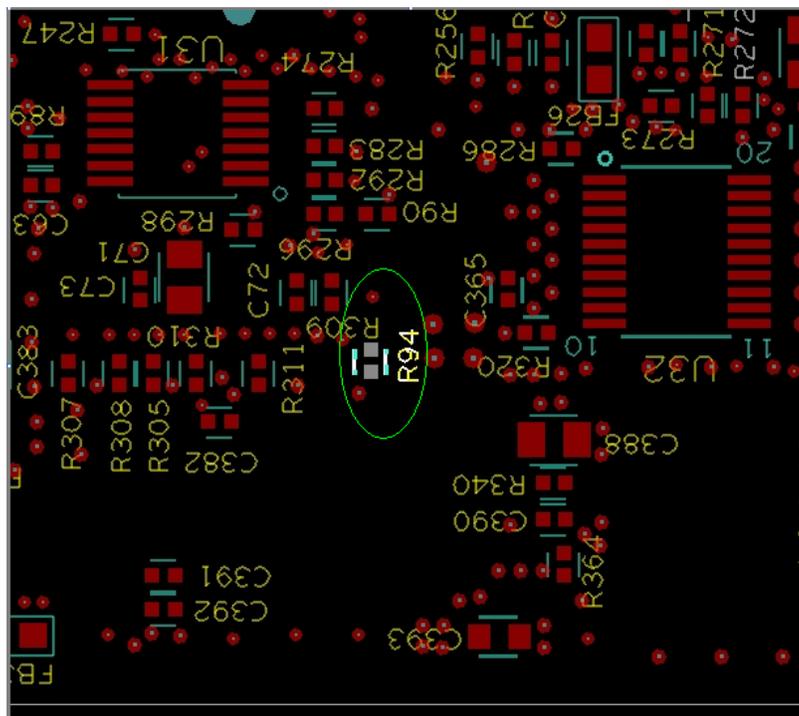
Figure 1. Location of R94 -- Bottom side of PCB near U32

**Details:** A bug has been found in the SerDes interfaces of TMS320C6474 that causes a SerDes clocking problem in normal functional operation. This problem will not occur when external pull-down is applied on the TCK pin (JTAG controller clock). SerDes are used in the Ethernet interface (EMAC), Serial RapidIO® interface (SRIO) and the Antenna Interface (AIF).

The TCK pin (JTAG controller clock) is internally assigned to an internal signal that is used by the SerDes macro. For the SerDes macro to get proper clocking in the normal functional operation, it needs the internal signal to be held low. However, there is an internal pull-up on the TCK, creating problems for SerDes operation. This problem exists on all SerDes interfaces.

In TMDSEVM6474L this issue may cause EMAC loop back test to fail randomly during Power On Self Test (POST).

A pull down is needed on TCK, to do that:

1. Un-mount pull up resistor R94 (4.7K) from net TG\_TCK. Refer below figure for the location of R94.

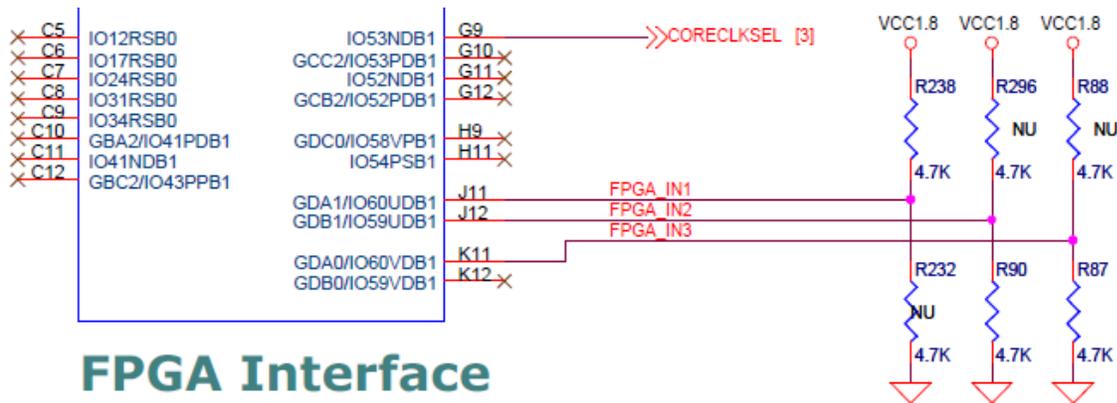
**Figure 1: Board version resistor assembly**

**Details:** During POST execution the board version displayed on the UART console does not match the PCA/PCB major revision indicated on the board silk.

The version displayed by the POST is read from the FPGA, which reflects the board version set using the assembly of resistors shown below:
